VEHICLE RETURN GUIDELINES

OK TRUCKS
PRE-OWNED VEHICLES CERTIFIED BY **IVECO**

FOREWORD

This damage catalogue aims to prepare you for returning your IVECO vehicle when your usage period comes to an end.

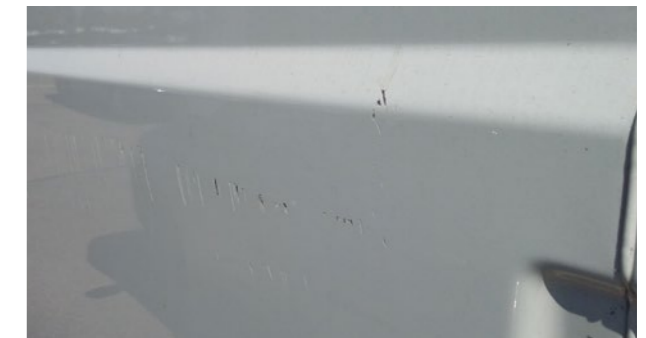
Irreparable parts, beyond economic repair or non-compliant exchanged part

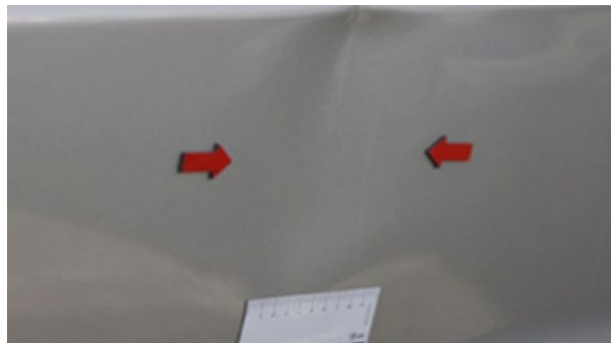
Indentations > 20 mm in diameter, altered paint, hail damage or significant pockmarks
NB: Smart repair possible on isolated, significant pockmarks if paint is not altered

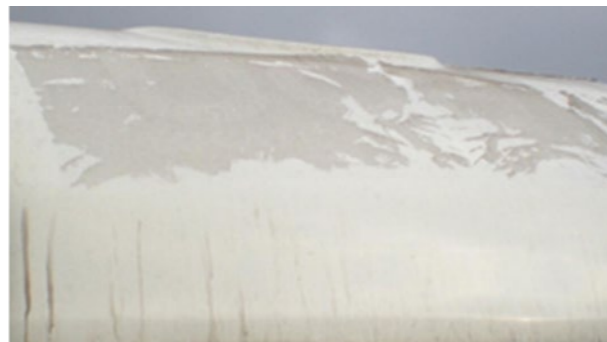
Trace of glue. NB: Presence of tags or graffiti, valuation in real time during cleaning and/or buffing

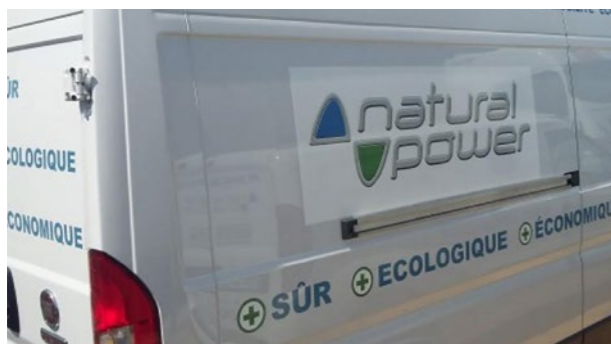
Marks left by advertisements following the description of the bodywork.

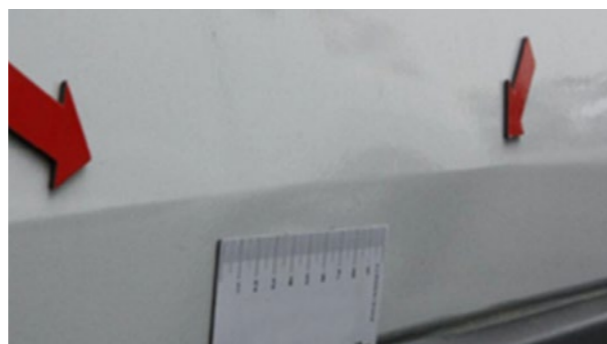
Defect: Deformed panel following repair

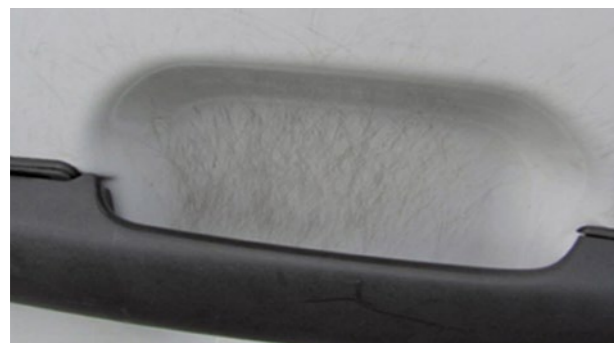
Faint superficial scratches, e.g. at the fuel filler cap, hatches, door handles, bumpers and trims

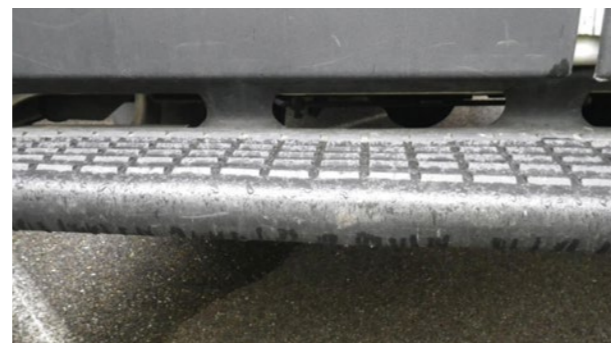
Faint scratches in the paint at the loading edges

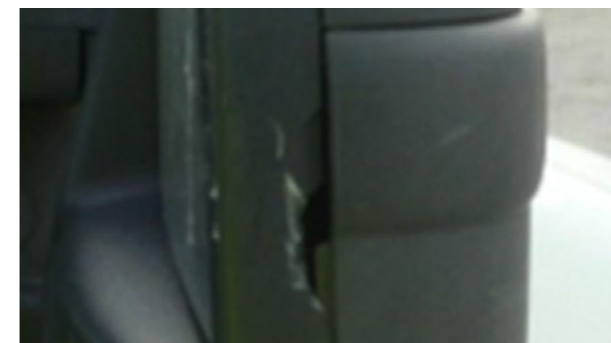
Removal of material, broken part

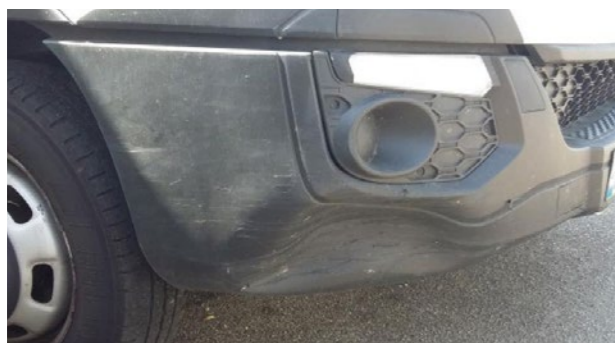
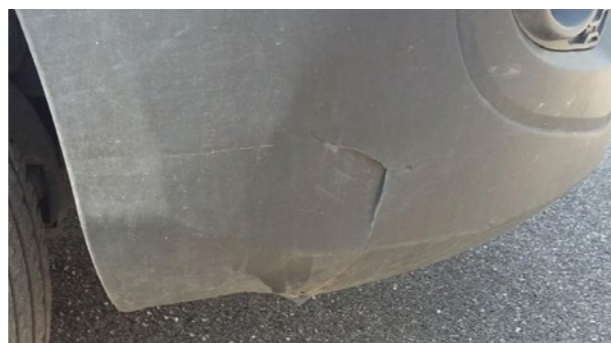
Broken, removal of material or deformation beyond economic repair or not feasible

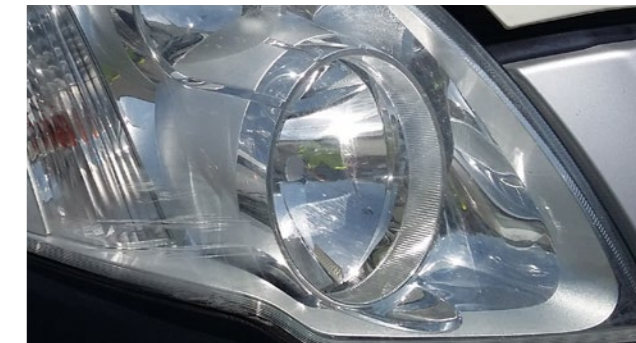
✂ Faint scratch (without removal of material), outside of lighting field and sealed light (BUFFING)

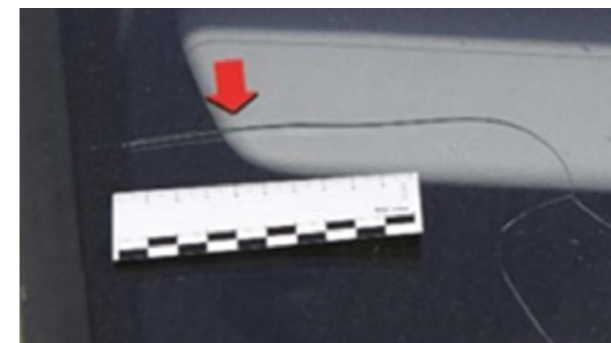
↻ Chips > 20 mm, number > 3 chips, or chips in the field of vision, cracked, poorly fitted with defect, sandblasted or scratched
 Note: If the windscreen is damage in the driver's field of vision, local legislation must be checked.

Note: The field of vision is defined by an A3 sheet of paper positioned vertically in the steering wheel axle and centred vertically on the windscreen.

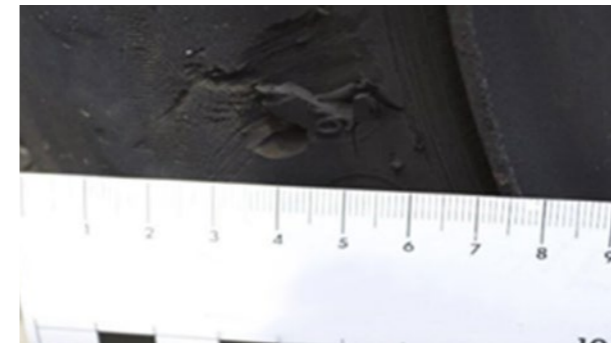
Tyres: Notch $>$ 3 mm deep, removal

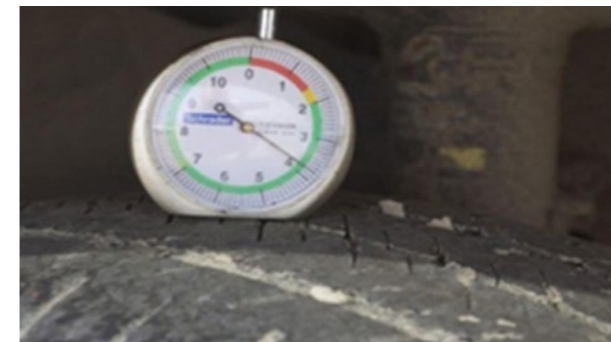
Tyres: Base of groove depth $<$ 5 mm
Note: The wear of the tyres is measured in the most worn groove on the tyre.

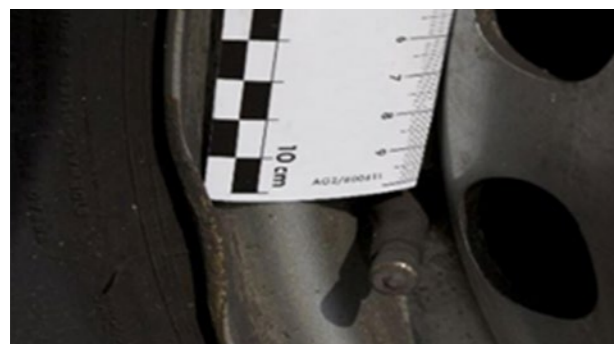
On steel rim: Attachment edge slightly deformed

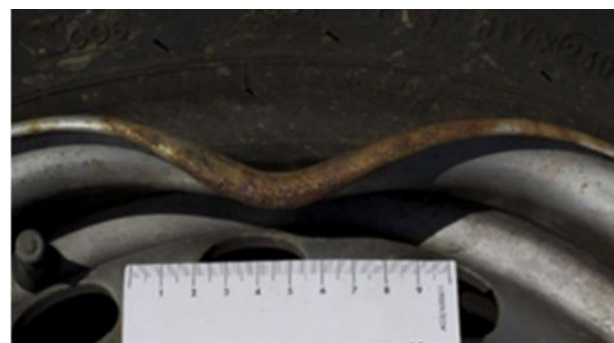
Wheel rim circumference, damaged non-compliant rim. Valuation of a dimensional check to check safe state of the vehicle

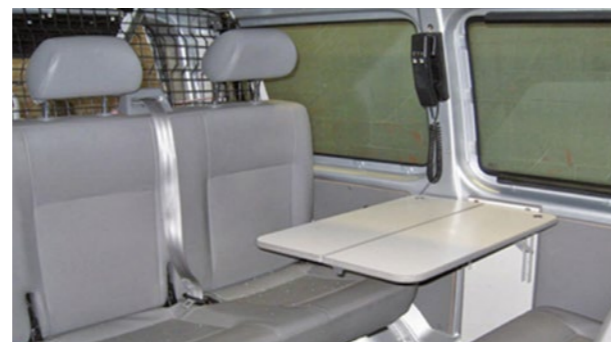
🔄 Burn > 3 mm, perforation or tear in the cover, without deterioration of the foam

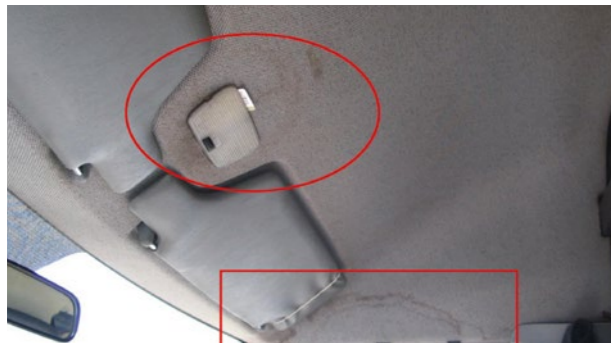
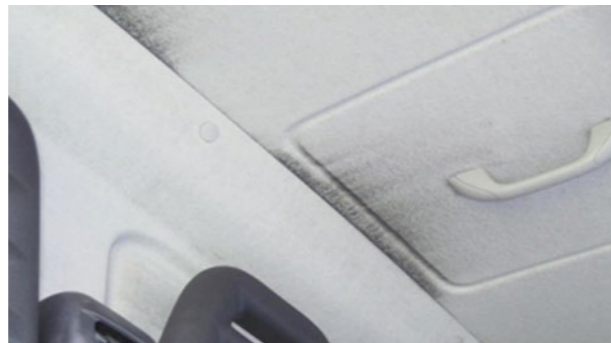
Significant soiling, stains and smells requiring chemical cleaning carried out by a professional.

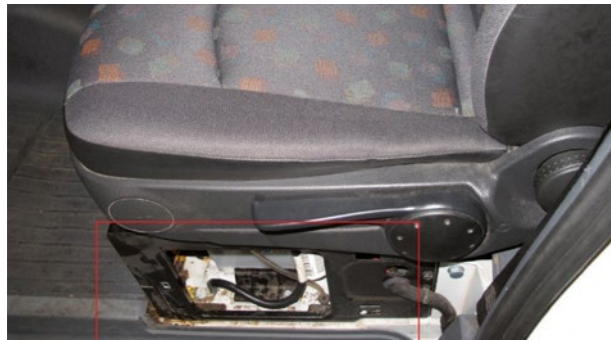
Missing equipment or trim pieces

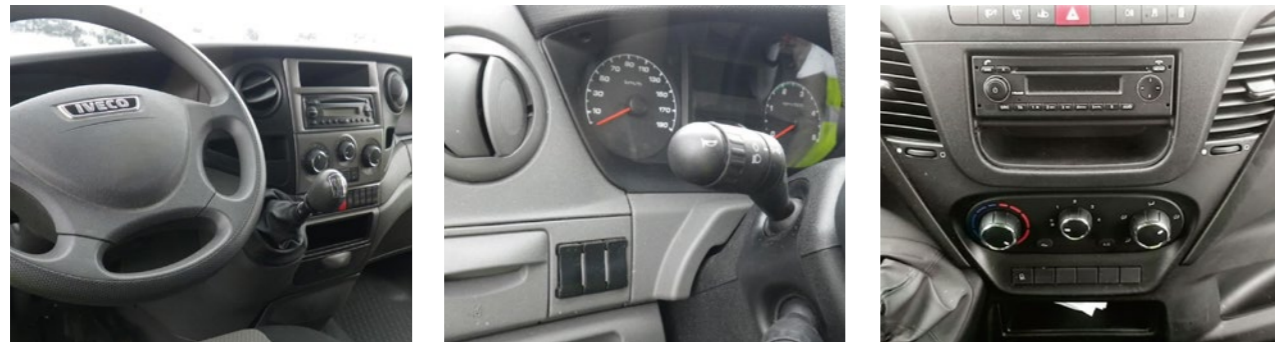
Traces of wear on the instrument panel, instrument cluster and steering wheel

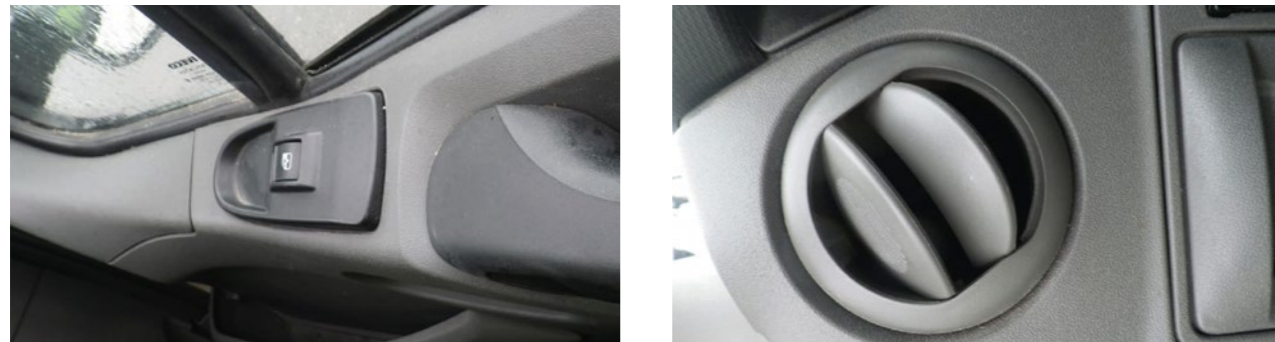
Slight decolouration due to sun exposure

Light soiling can be removed by chemical cleaning carried out by a professional

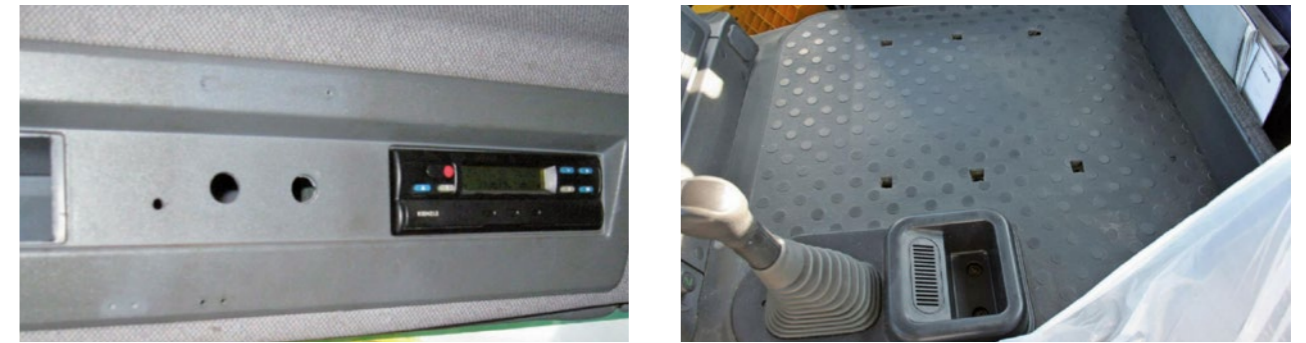
Control parts, seat or trim pieces missing, broken or pierced

Systems, seatbelt, seat control, displays and visuals not operating

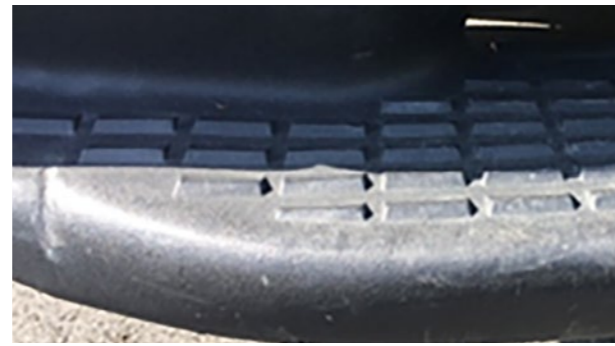
🔧 Rear footboards: Deformations within economic repair

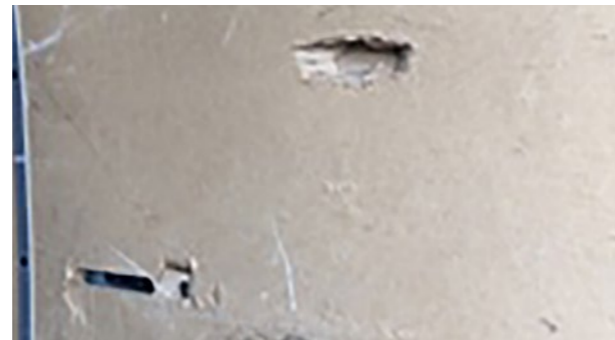
🔄 Internal deformations: Significant deformation, repair time > 3 h, perforations, cuts

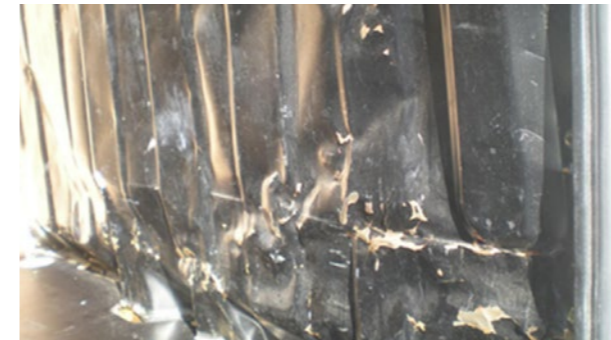
🔄 Internal deformations: Perforations, cuts, deformations beyond economic repair. Denaturing and uncorrectable deposit (powder, paint, etc.) (Wheel arch not recoverable if repair time > 3h)

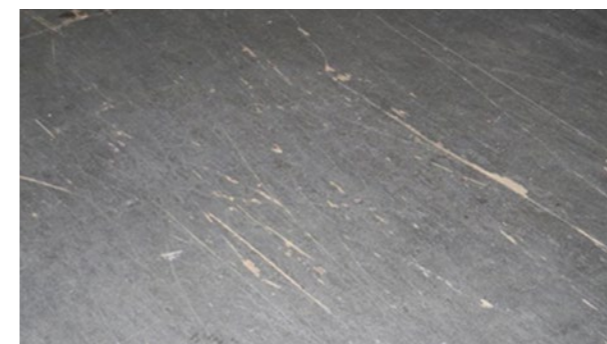
☰ Flooring: Slight deformation, superficial wear

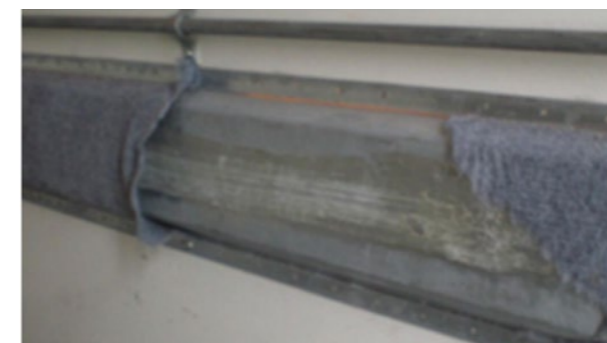
☰ Upholstery and rods: Carpet torn or detached

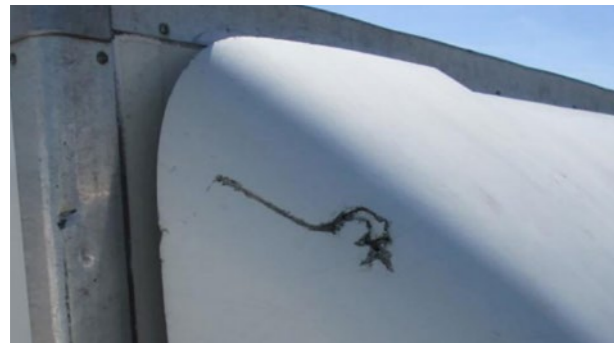
Cabover and deflector: Within economic repair

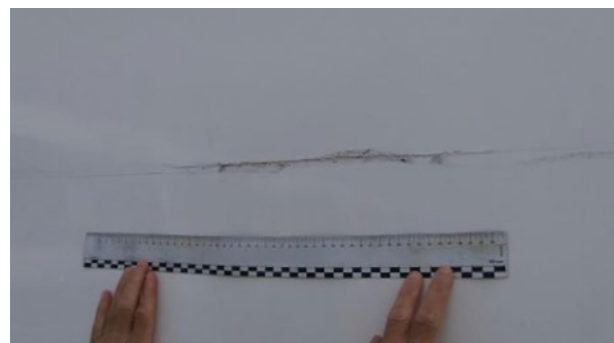
Side panels: Scratch with removal of material $\geq 20\text{cm}$ within economic repair. Option to paint half panel

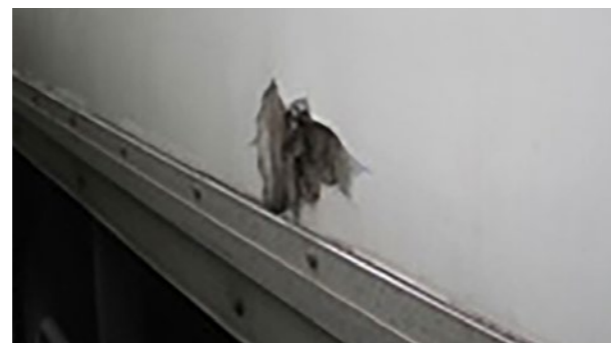
Wood side panels: Damaged wood support $\geq 20\text{ cm}$

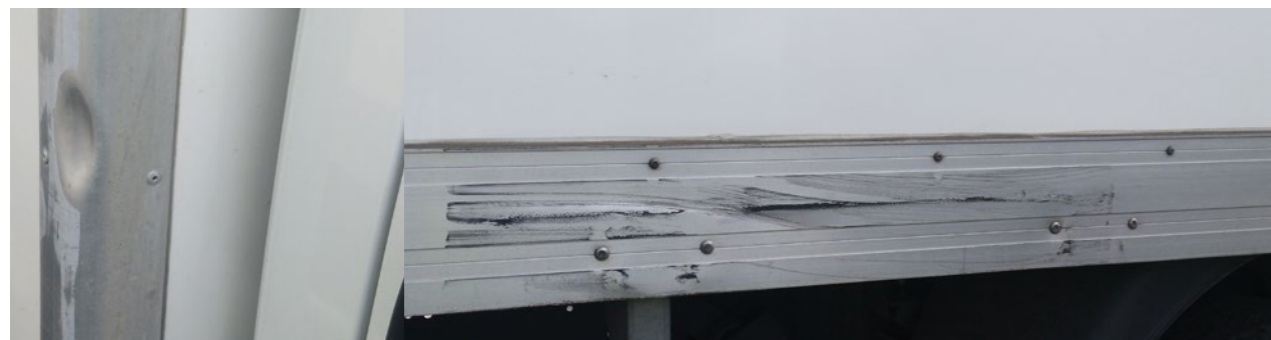
Underbody side profiles: Deformations within economic repair

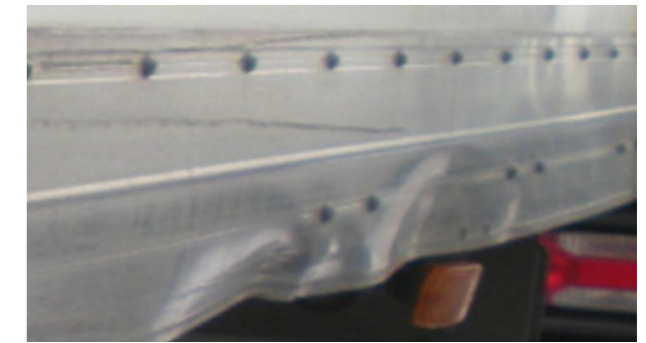
Underbody side profiles: Deformations beyond economic repair, perforations, removal of a section of the profile

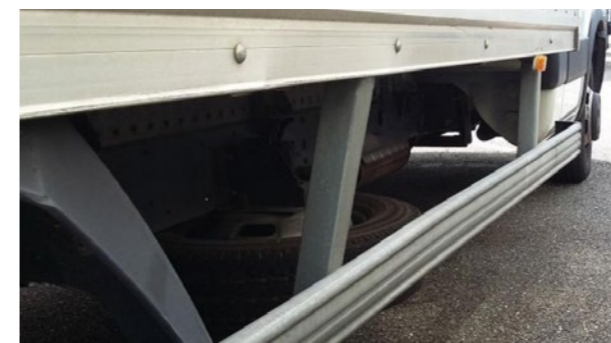
Side underun guards: Deformation within economic repair

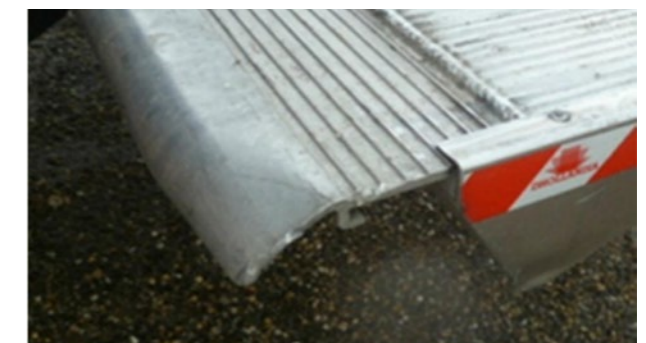
Tail lift: Deformations of platform within economic repair

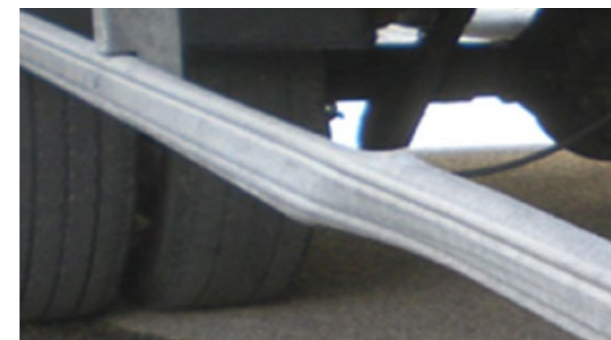
Side underun guards: Deformation beyond economic repair

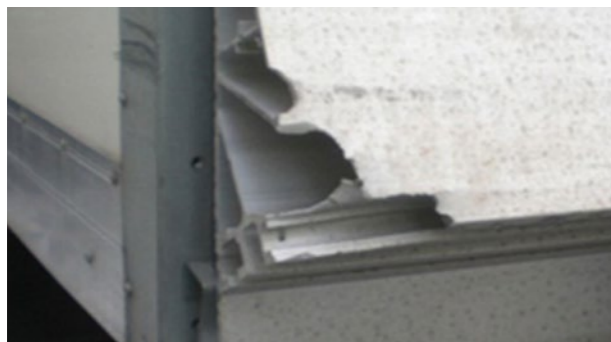
↻ Tail lift: Deformations of platform beyond economic repair; broken or incomplete trim

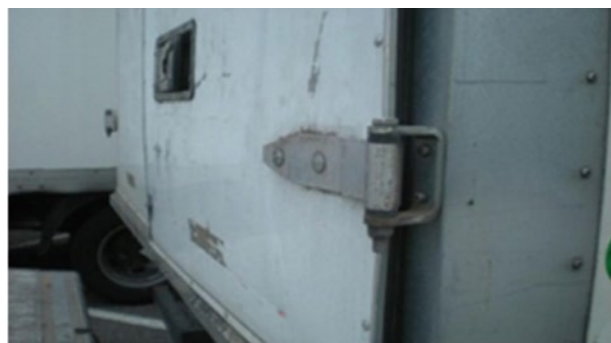
↻ Side and rear doors: Doors bent at fastening points for hinges, broken, perforated, or beyond economic repair

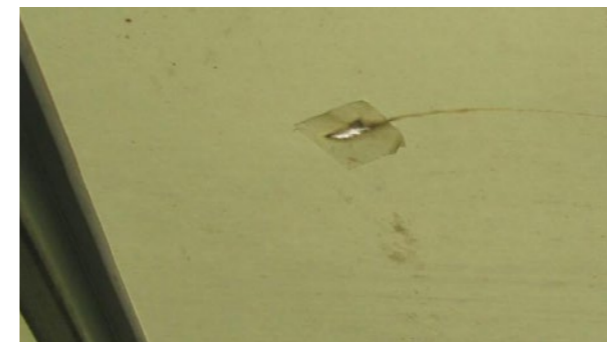
🔧 Roof space: Perforated or torn within economic repair

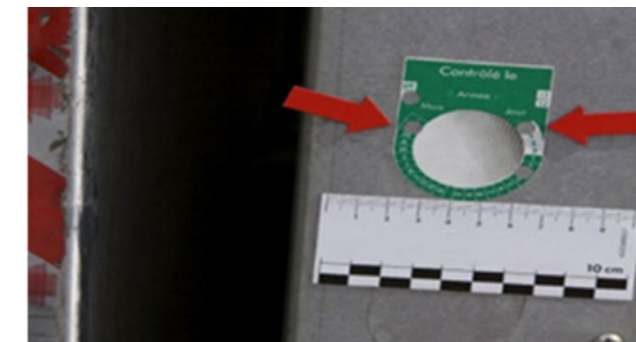
🔧 Tail lift: Expired check dates

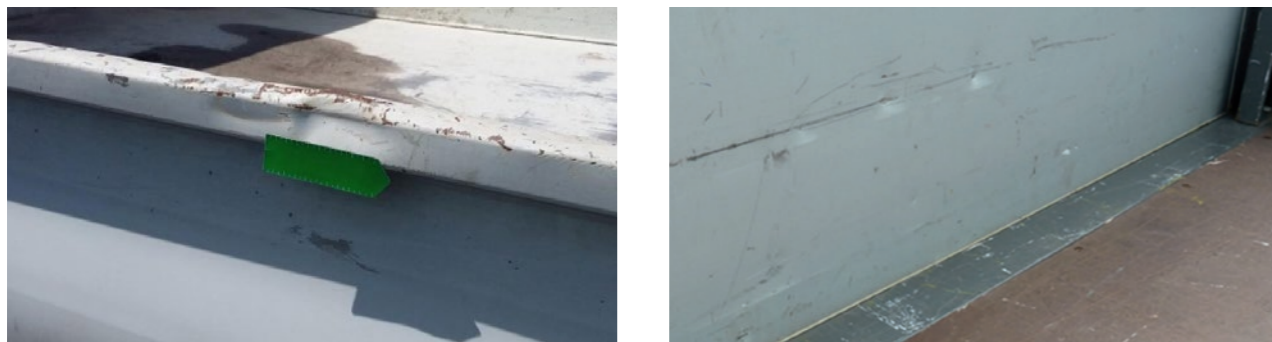
Faint scratches, Dropside/ Tipper Bodies deformations with a repair time \leq 1 h

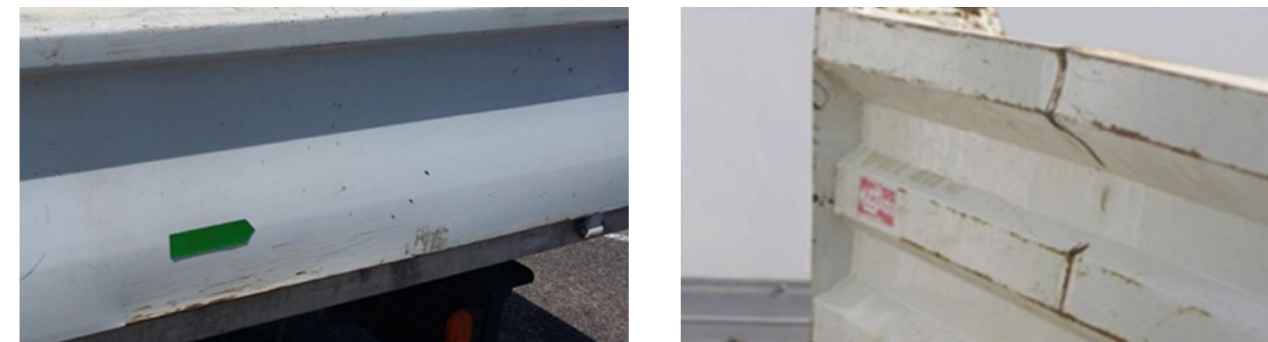
Scratches > 20 cm

Deformations in the body closures with a repair time > 1 h within economic repair

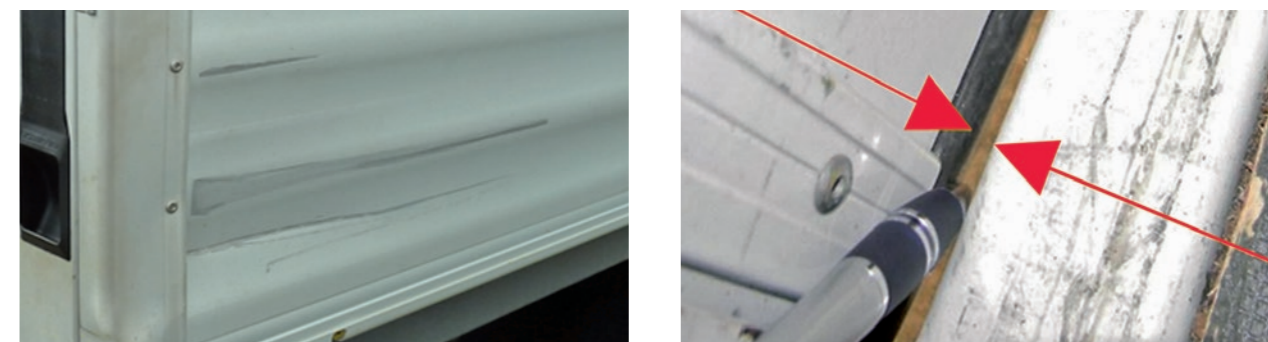
Deformations in the body closures not beyond economic repair, closure not possible or not sand-proof

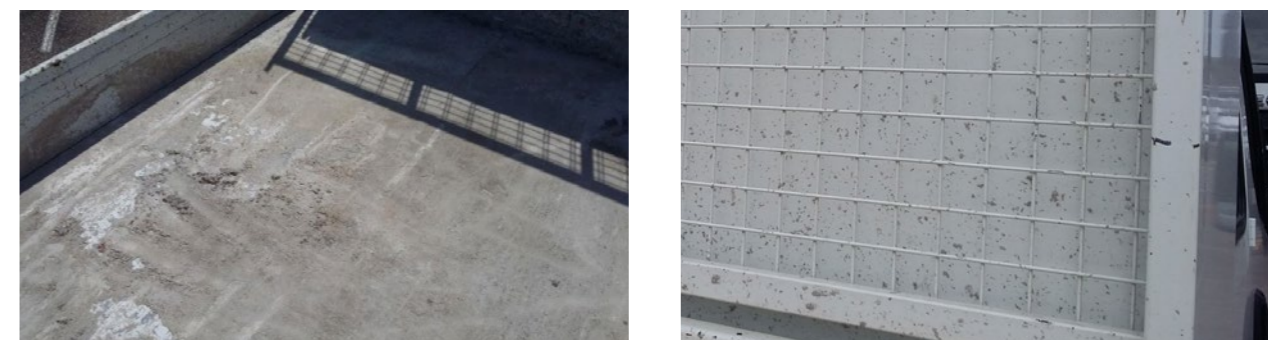
Trace of concrete or chemical product covering \geq 1/4 of the surface of the bed

Trace of concrete or chemical product on the back of the cab

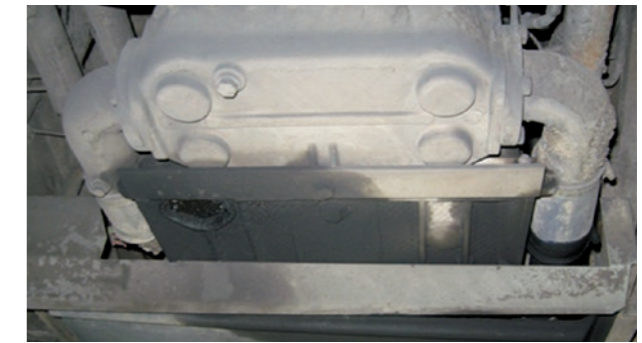
All Leaks from the engine, gearbox and differential, hydraulic suspension and dampers

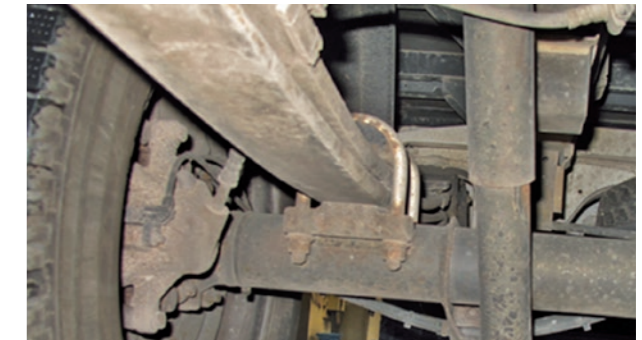
Leaks from the steering gear and power steering pump

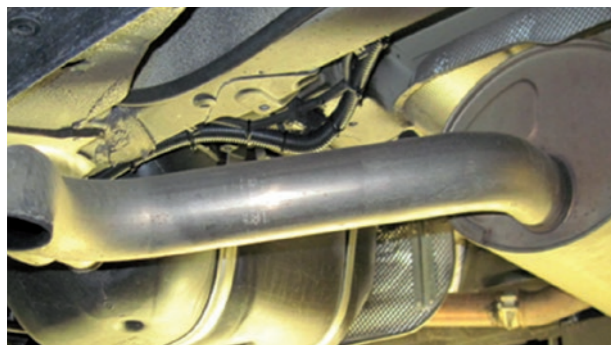
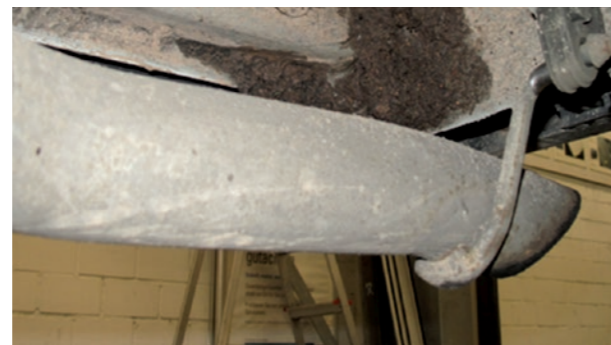
Condition conforms to technical inspection

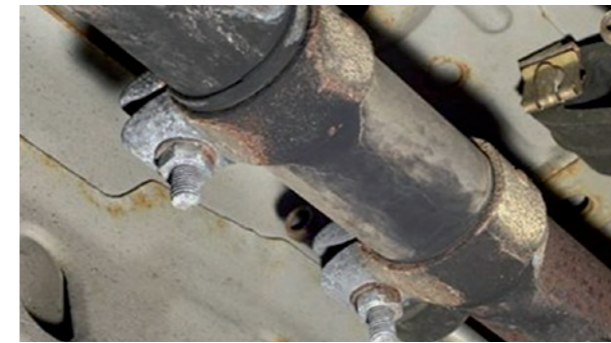
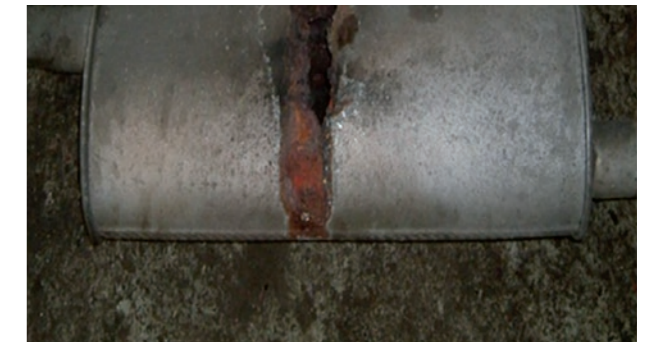
- Presence of leaks
- Rust

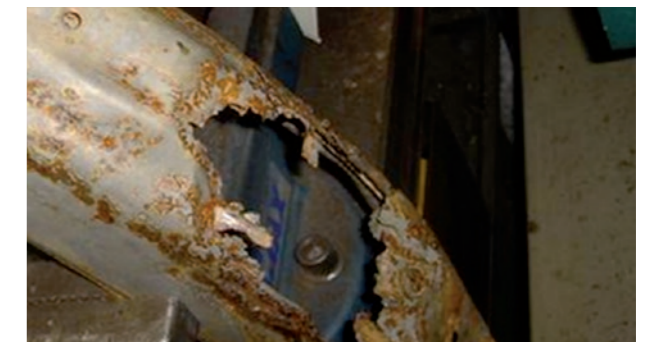
- Damage due to external shocks
- Missing equipment, e.g. exhaust outlets torn or deformed

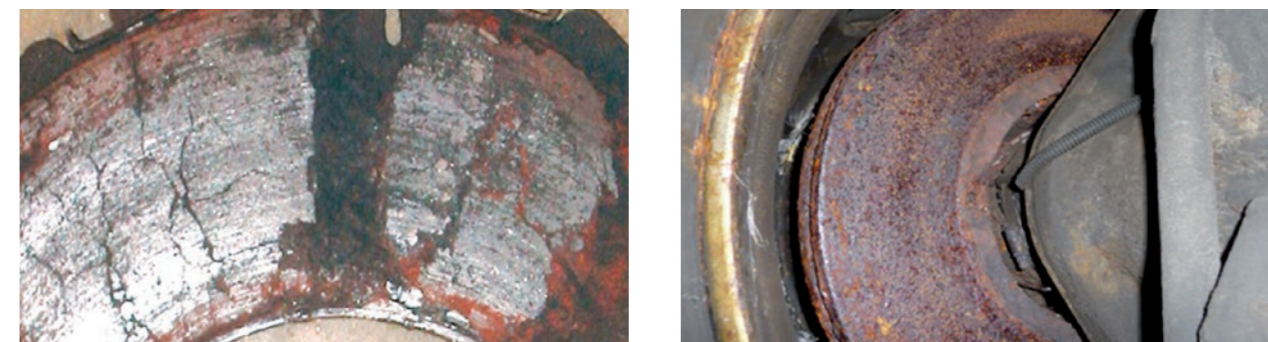
Rusted, ground, worn brake discs

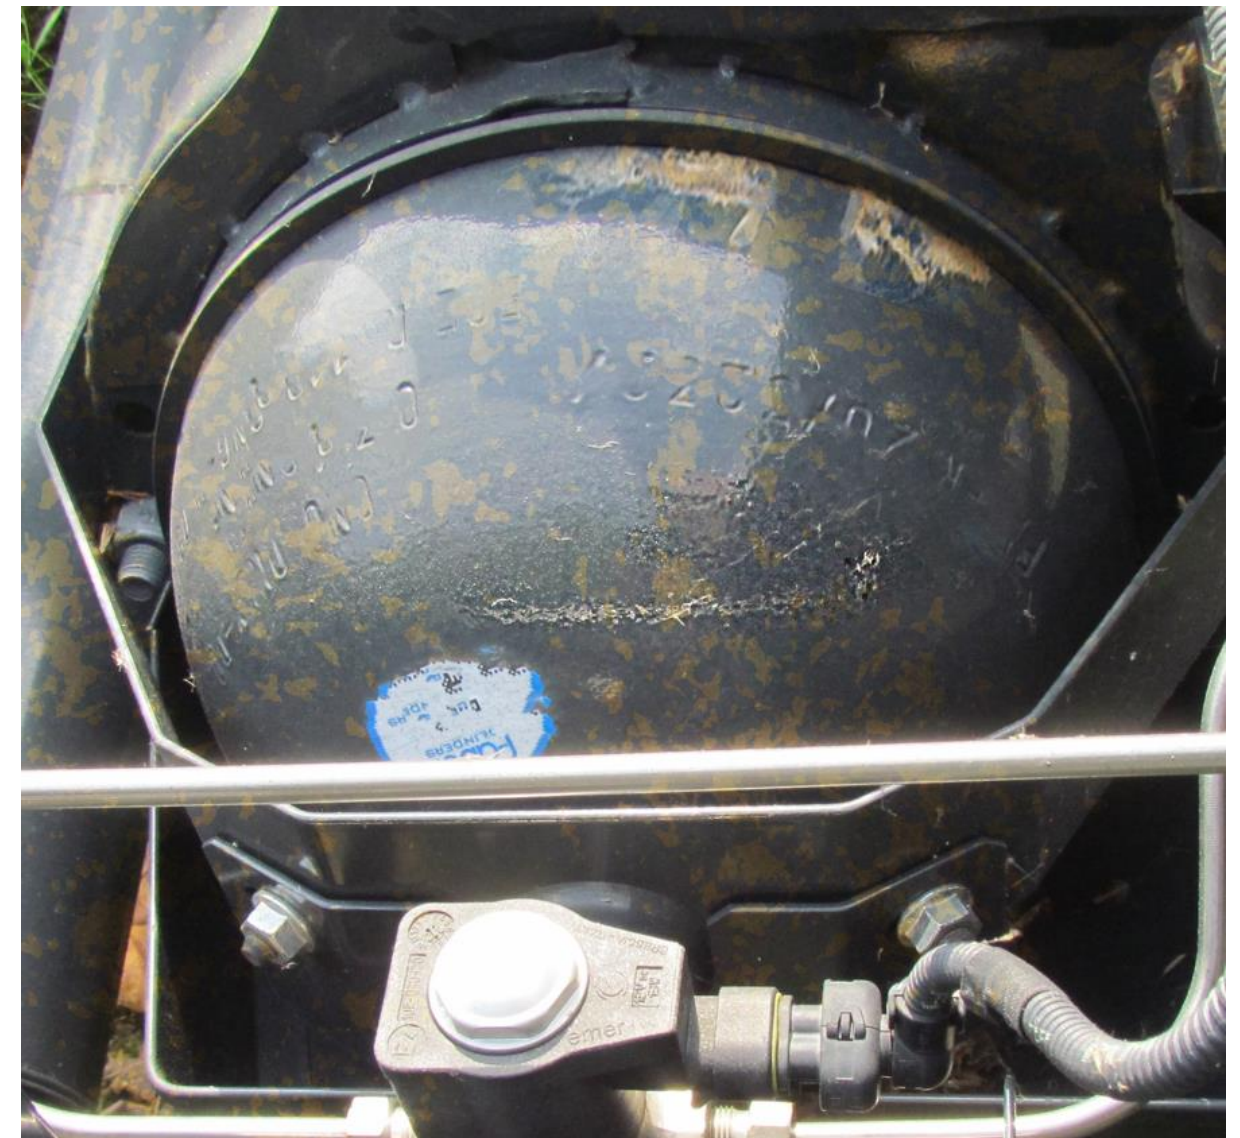
- Original **CNG cylinder identification markings** absent or illegible → charge for replacement of CNG tank with a new one.

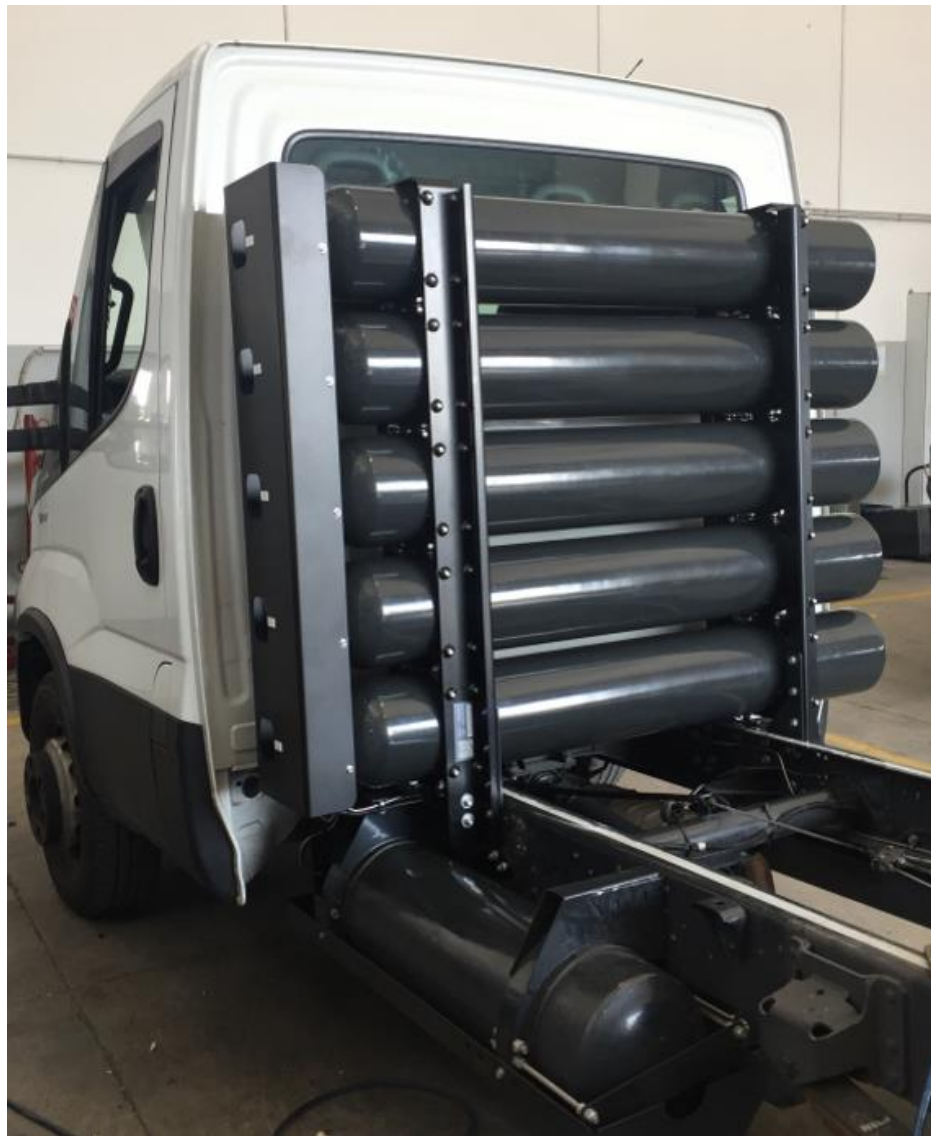
CNG CYLINDERS

CNG cylinders must be returned in proper conditions as illustrated in pictures.

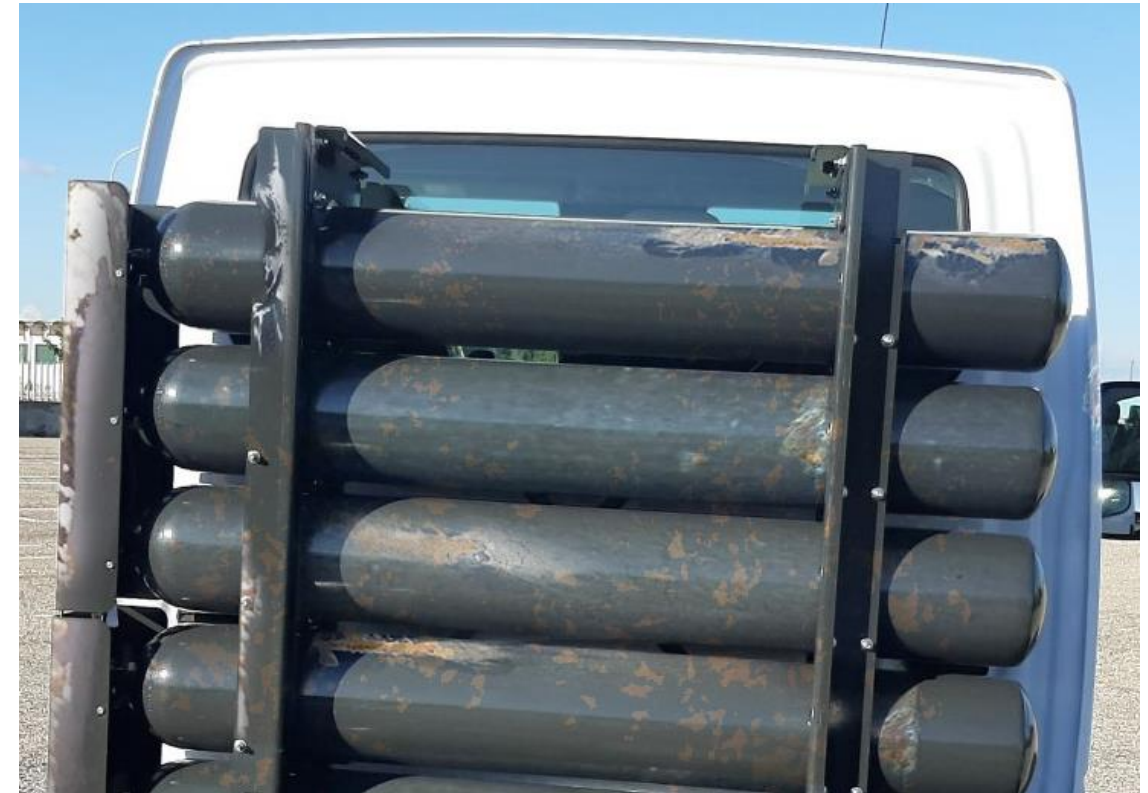
- Evidence of **repairs to the CNG cylinder** → charge for replacement for CNG cylinder.
- **Holes in the CNG cylinder** → charge for replacement for CNG cylinder.

- **Dents on the CNG cylinder:**
 - If no metal is detached and the **maximum depth** of the deformation is ≤ 1.6 mm and ≤ 50 mm in diameter/length → note without charge for damage.

- Detachment of metal or **maximum depth** of deformation > 1.6 mm and > 50 mm in diameter/length → charge for replacement of CNG cylinder.
- **Cuts/scratches/gouges/abrasions** on the CNG cylinder:

- **Depth of damage** ≤ 0.25 mm → note without charge for damage.
 - **Depth of damage** > 0.25 mm → charge for replacement of CNG cylinder.
- **Corrosion, pits**, corrosion lines caused by a chemical, **oxidation or rusting** of material:

- **Depth of damage** ≤ 0.25 mm → note without charge for damage.
 - **Depth of damage** > 0.25 mm → charge for replacement of CNG cylinder.
- **Gas leakage** from any CNG cylinder or component, **due to a defect** → charge for replacement of the CNG cylinder or component.

- **Bulge/visible swelling** of the CNG cylinder → charge for replacement of the CNG cylinder.
- Permanent **traces of chemical attack**/permanent **discoloration, loss** of material from the CNG cylinder → charge for replacement of the CNG cylinder.

- Permanent **traces of charring/soot/blackening/dyscoloration**, evidence of **fire** or **excessive heat exposure** of an area of the CNG cylinder → replacement of the CNG cylinder.

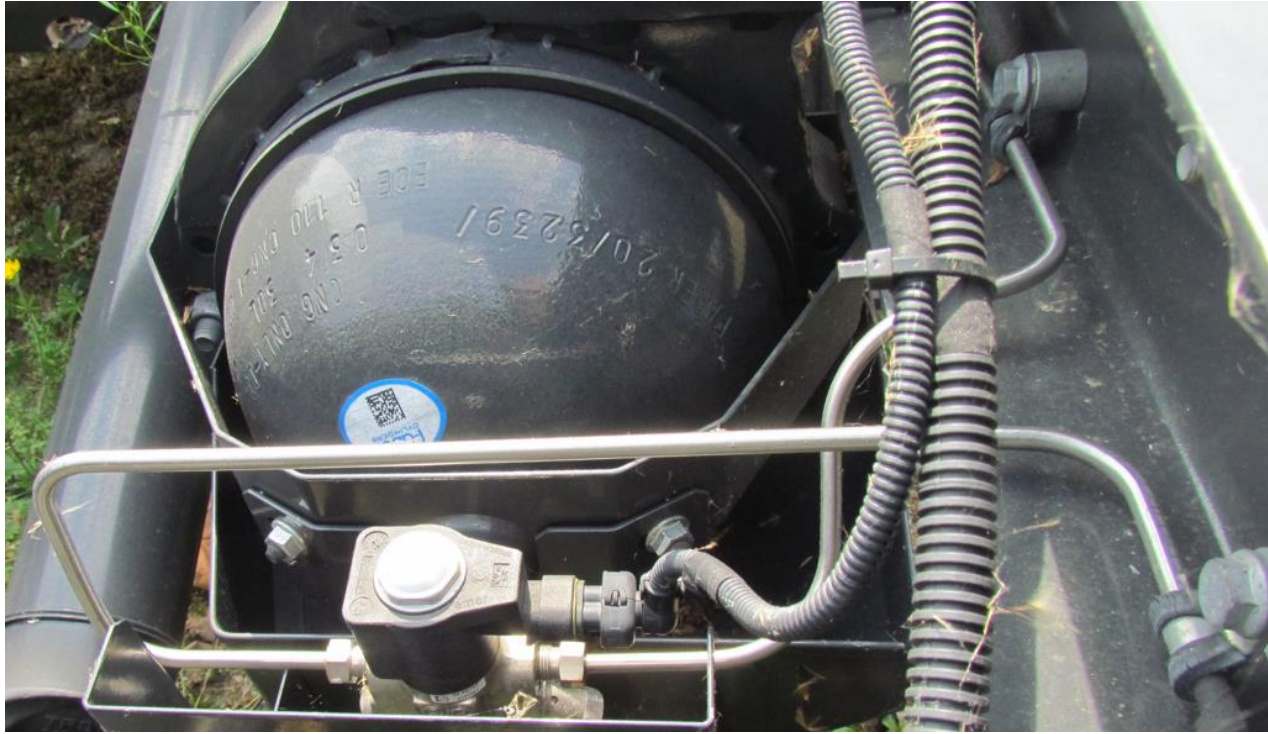
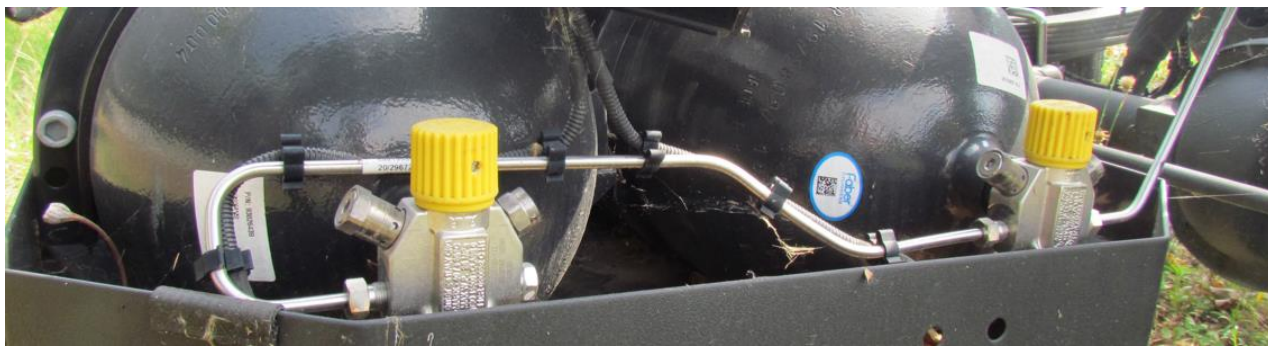
RIGID LINES FOR CNG CYLINDERS

Rigid lines must be returned in proper conditions as illustrated in pictures.

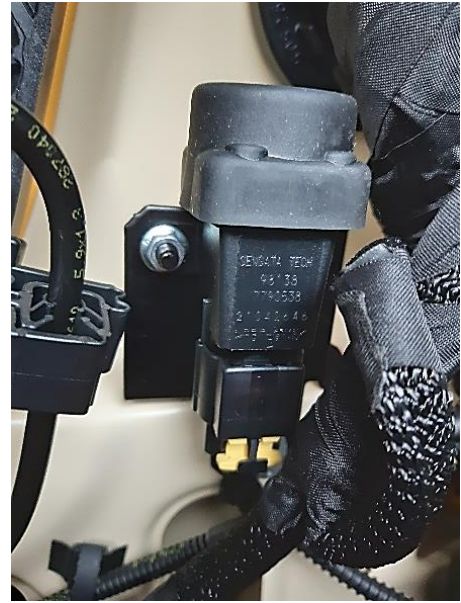
EV

- a) To remove electrical connection
- b) During key on, the Electro Valve (EV) must be remained off

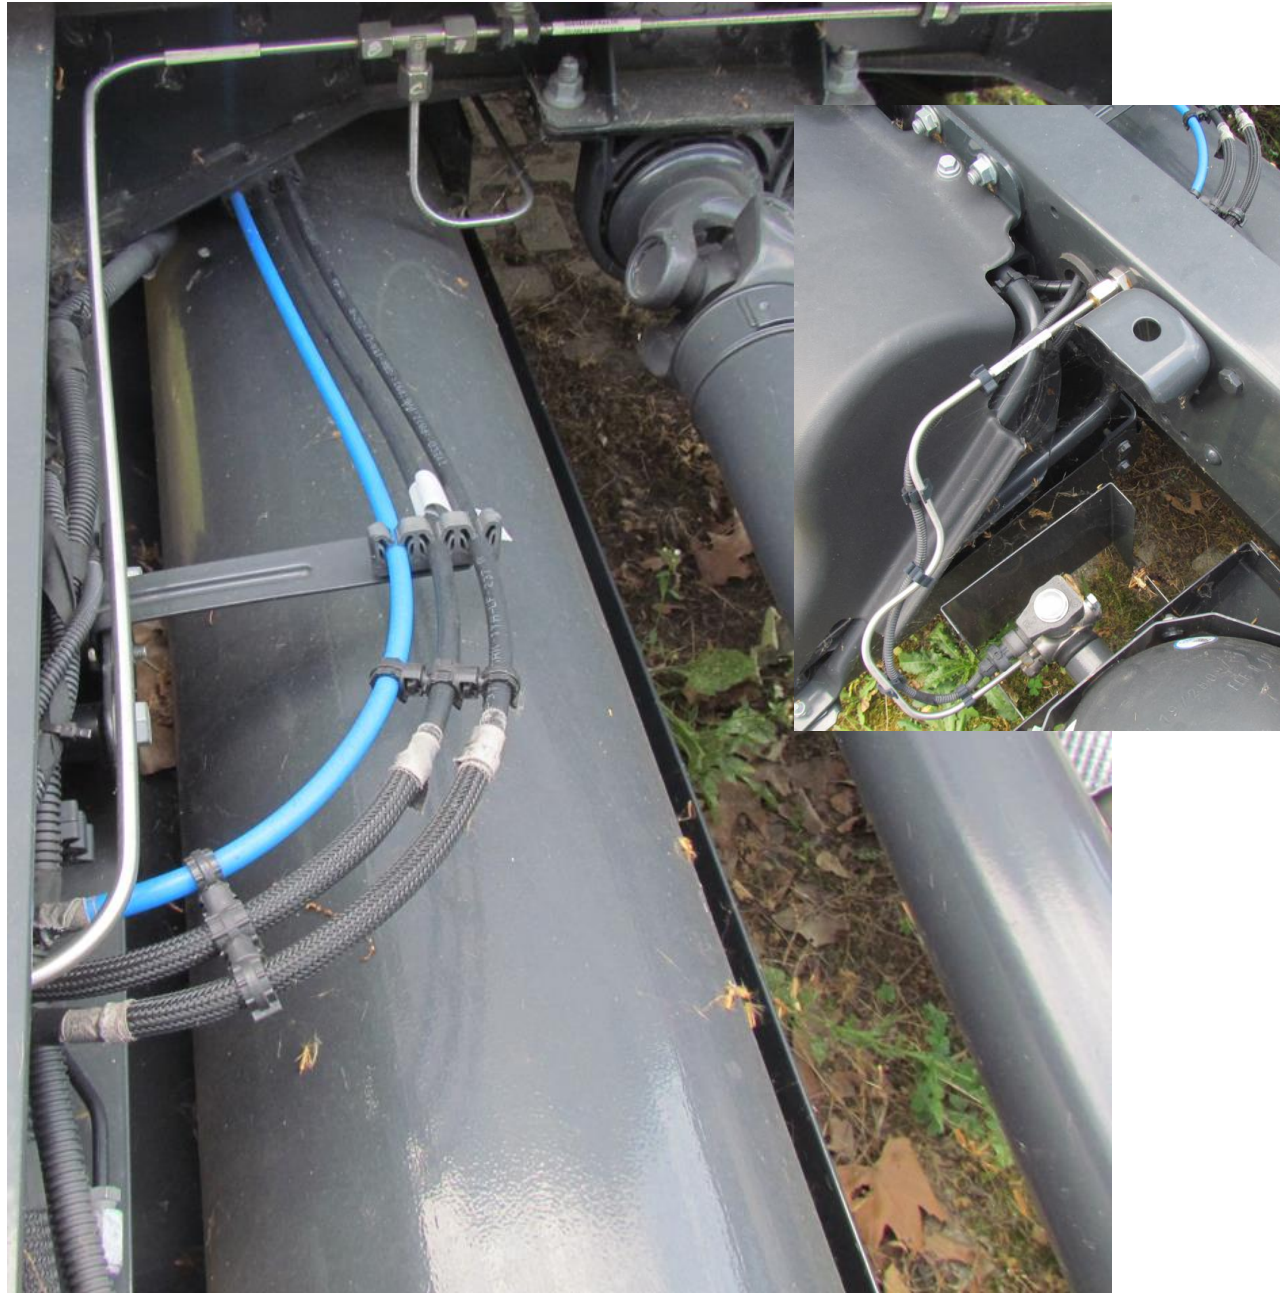
INSPECTION OF GASOLINE FUEL LINE

Check integrity of the gasoline fuel lines (no losses, no evidence of deep scratch). Fuel lines must be returned in proper conditions as illustrated in picture.

- Losses or evidences of **deep scratches**
→ charge for replacement of fuel lines.
